**Kilbourn Reservoir Park Project Update May 12, 2008**

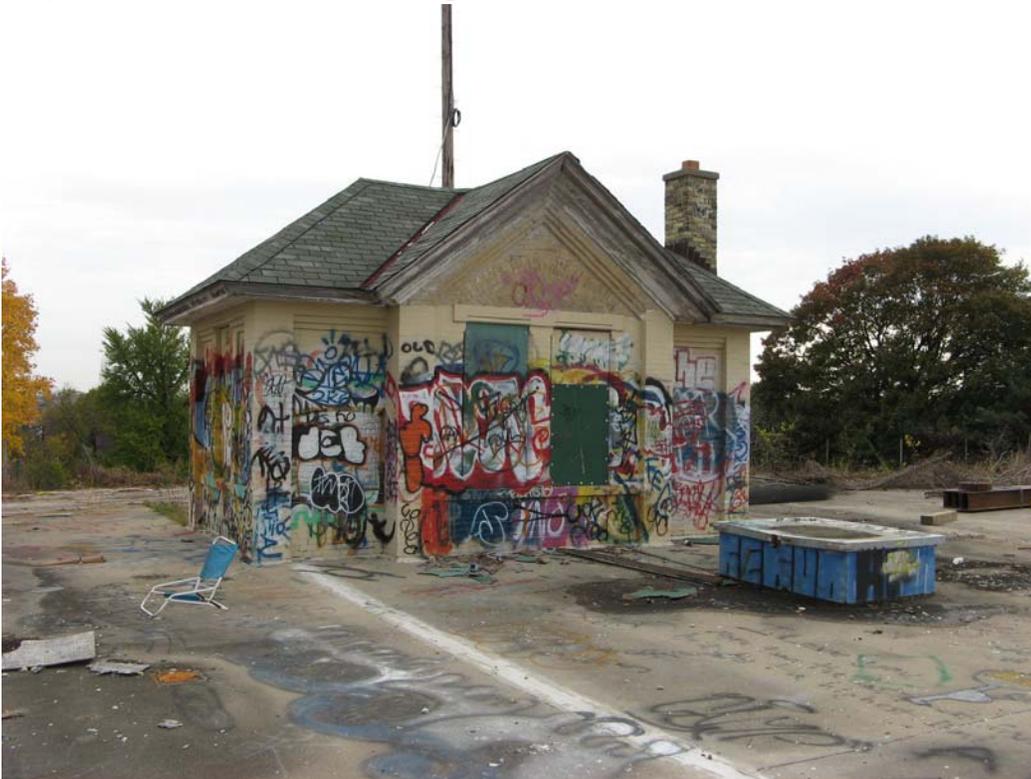
The 12'x22' four-walled brick gatehouse structure was built as a cover to protect gate valves on top of the reservoir. It was never occupied. The structure had only a wooden floor and no foundation; it essentially is a shell. The chimney is ornamental. This Oct. 23, 2006 photo captures the chronic problem of graffiti defacing the exterior.

We have received an estimate of \$250,000 to remove the graffiti and restore the building. This does not seem to be a prudent use of funds, especially if it continues to be a target for vandals and graffiti taggers. We are looking for suggestions for what could be done with the structure other than return the restored building to the top of the hill. Among the options considered thus far:

- Sell or give the structure to someone willing to move it from the park.
- Demolish the structure and recycle or donate the bricks.
- Leave the structure on the park property, cleaned of graffiti and sealed to prohibit entry. Again, there is concern the building may continue to be a target for vandals and graffiti taggers.

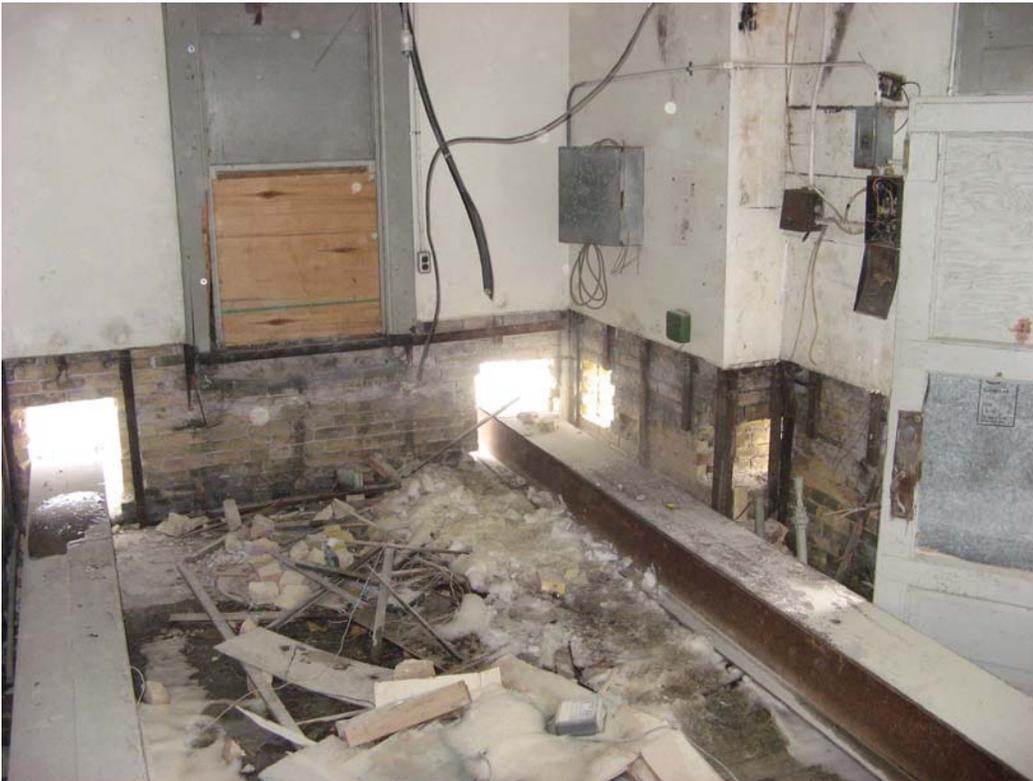
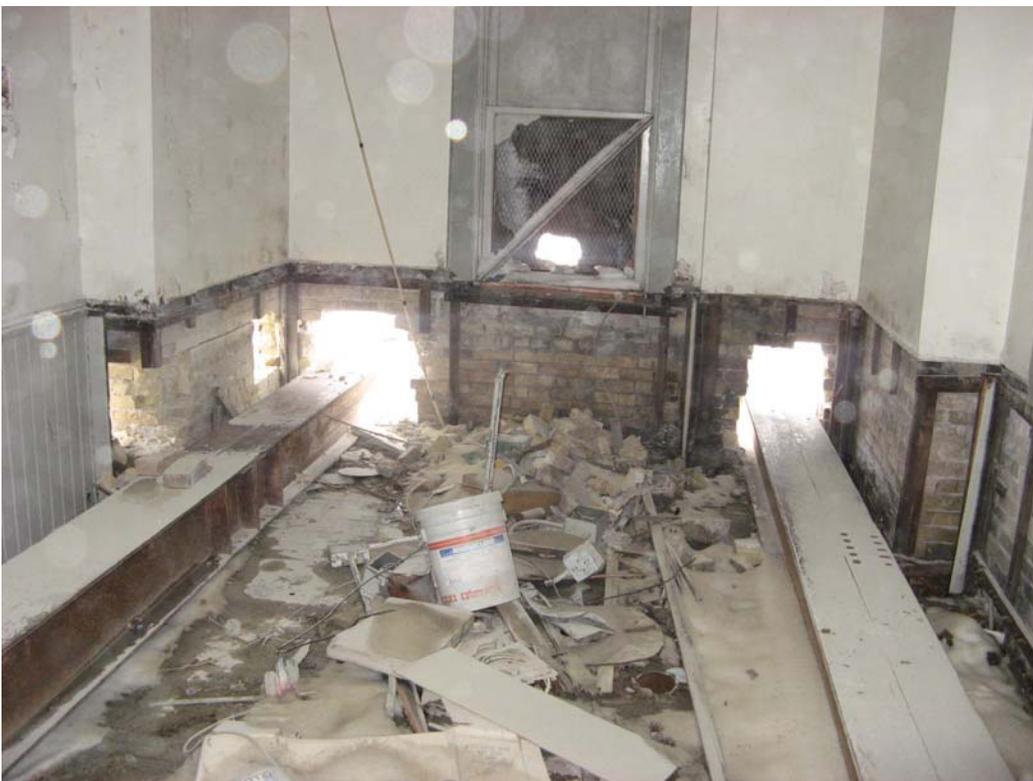
Before demolition of the reservoir beneath it, the structure was moved off the “hill” to the west side of the park. Because it has no floor, the contractor inserted beams into the walls of the gatehouse so it could be hoisted onto a trailer for moving. These interior views were photographed before the move.

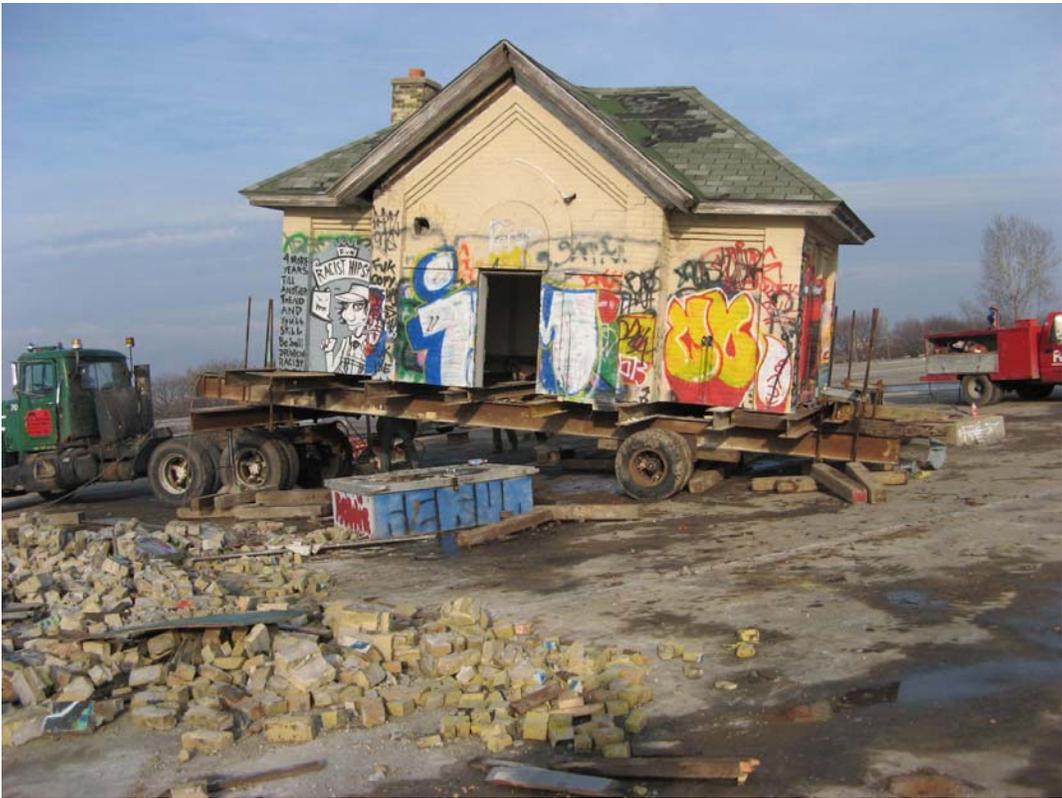
The gatehouse structure in transit (November 2006)

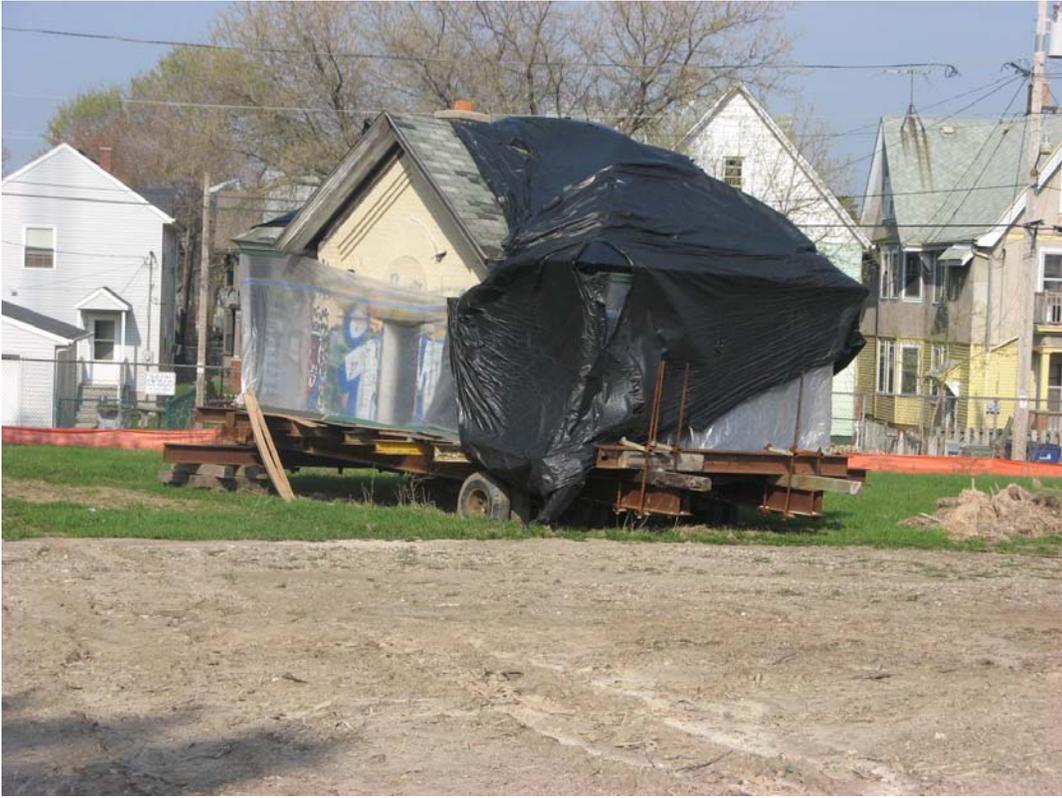
The structure rests on a trailer on the west side of the park. (May 1, 2008)

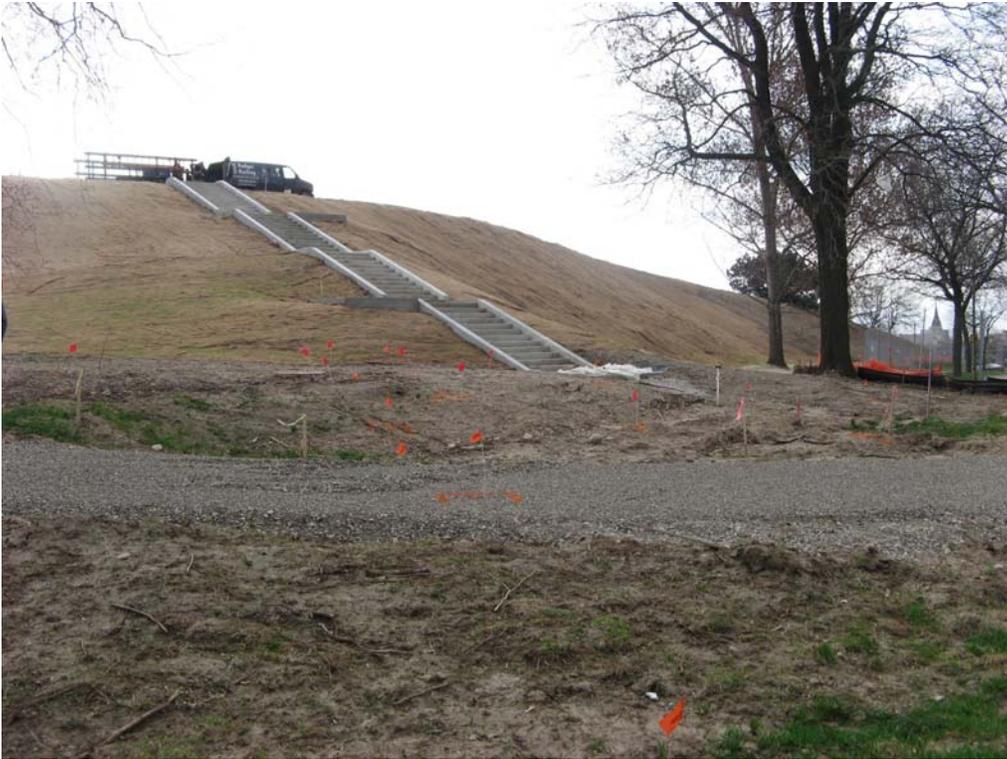
Underground wiring is marked with flags at the base of the western staircase before lighting is installed. Electrical wires will be trenched along walkways to avoid boring under the trees. Preparations are made for installing railings on the staircase. (April 23, 2008)

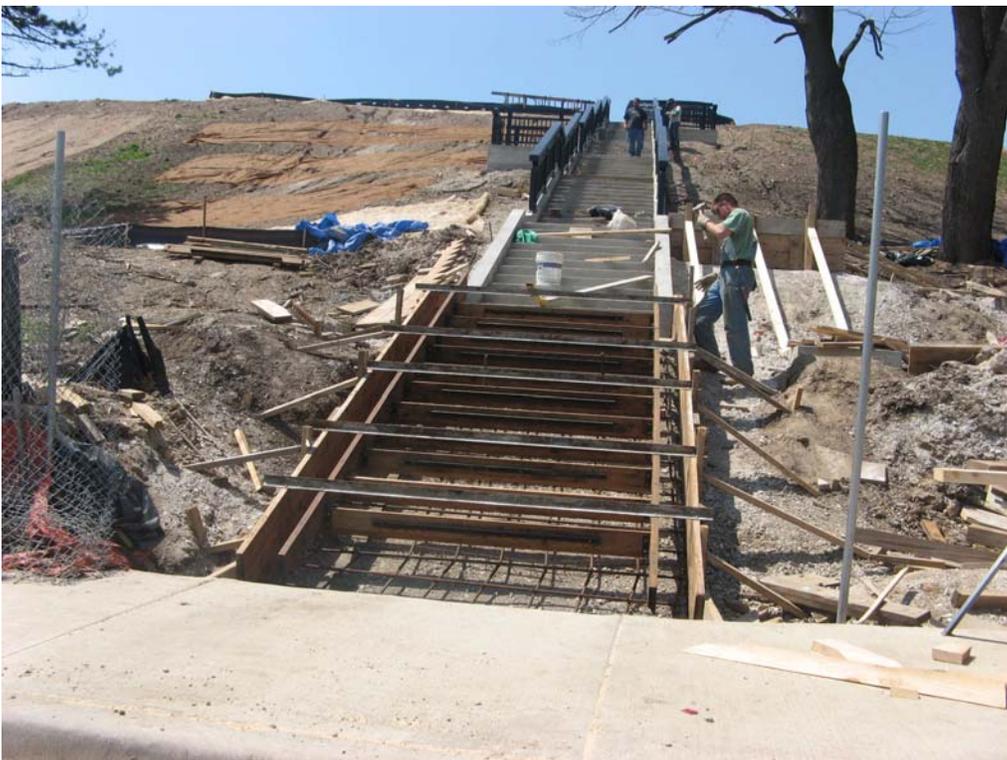
Workers frame east staircase and will install a short concrete wall near the east entrance to prevent erosion. (May 5, 2008)

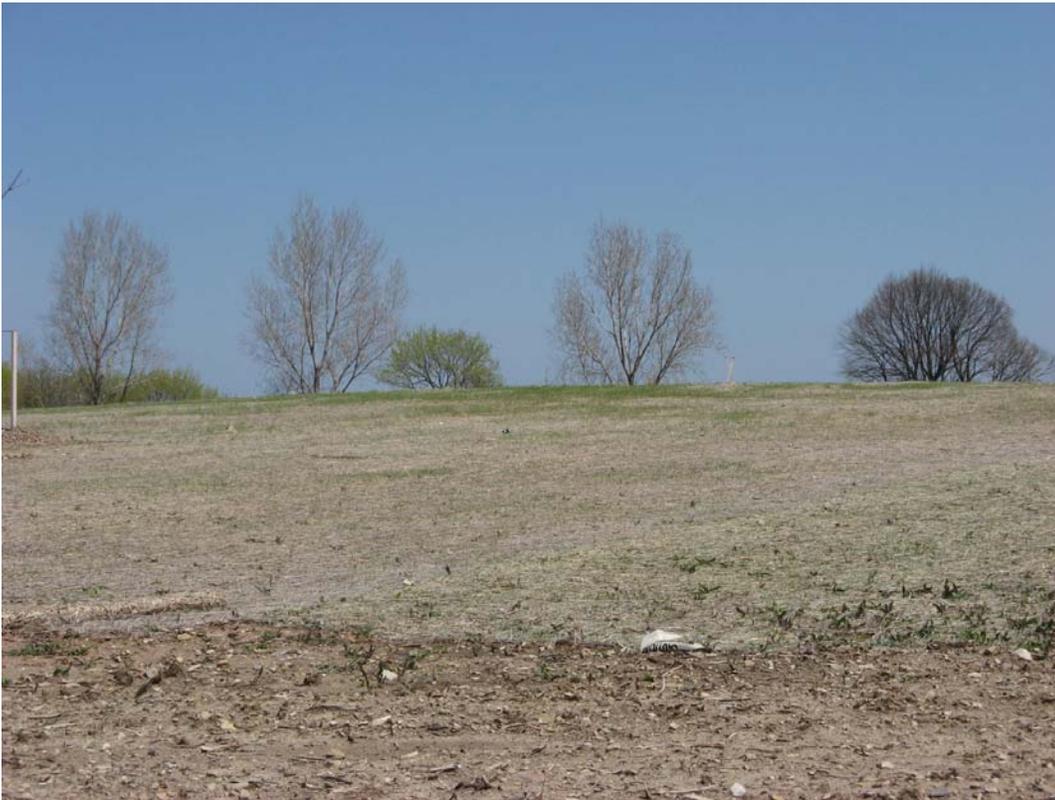
Site erosion control measures appear to be holding up despite recent rains. There are a few areas on the hill where grass has started to grow while other areas have yet to show signs of life. The grass seed will need the entire growing season without foot traffic on it so the hill will be covered with healthy grass for the full opening of the park in 2009. (May 5, 2008)

Our first request is that everyone allow the grass on the new hill to take root to avoid soil erosion. Although the work will be substantially complete by mid-July, most of the site will continue to be fenced off and closed until next spring. It is very important that the plantings and grass seed are allowed to take hold on the site to ensure their healthy growth and to prevent erosion of the site.
