**Historical Land Use Investigation of  
626 W. North Avenue  
Milwaukee, Wisconsin**

**File: 323-05**

**Department of City Development**

**April 20, 2010**

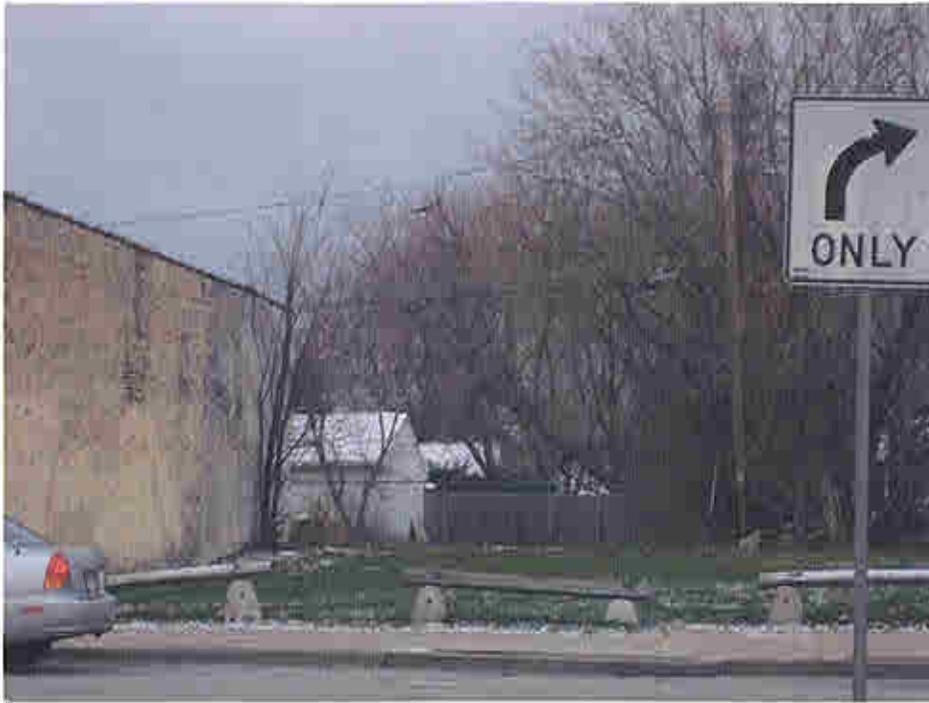
View of the project site facing north.

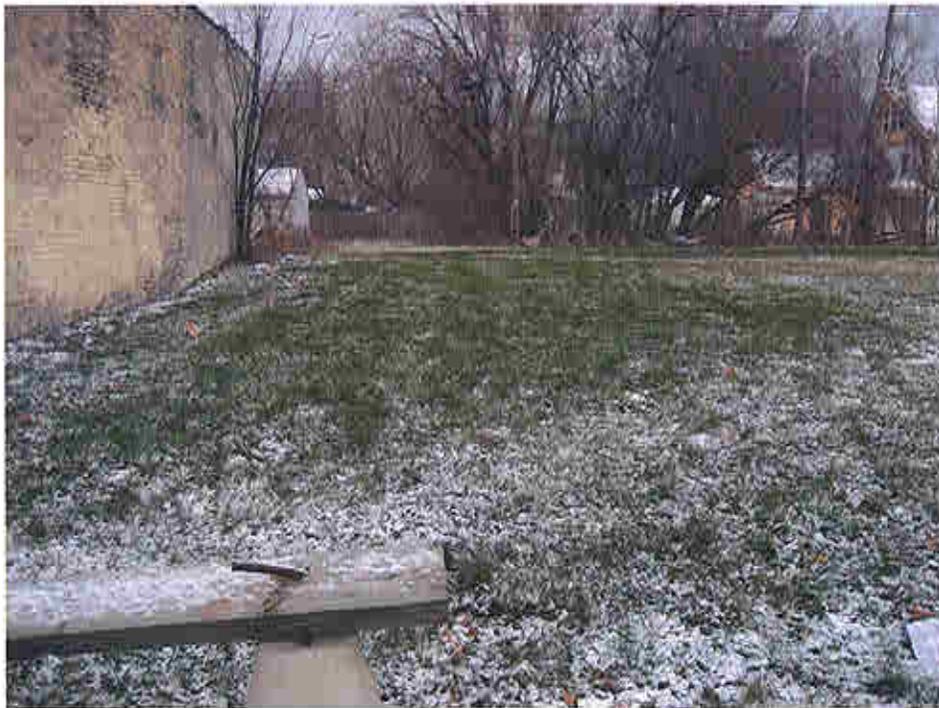
View of the project site facing north.

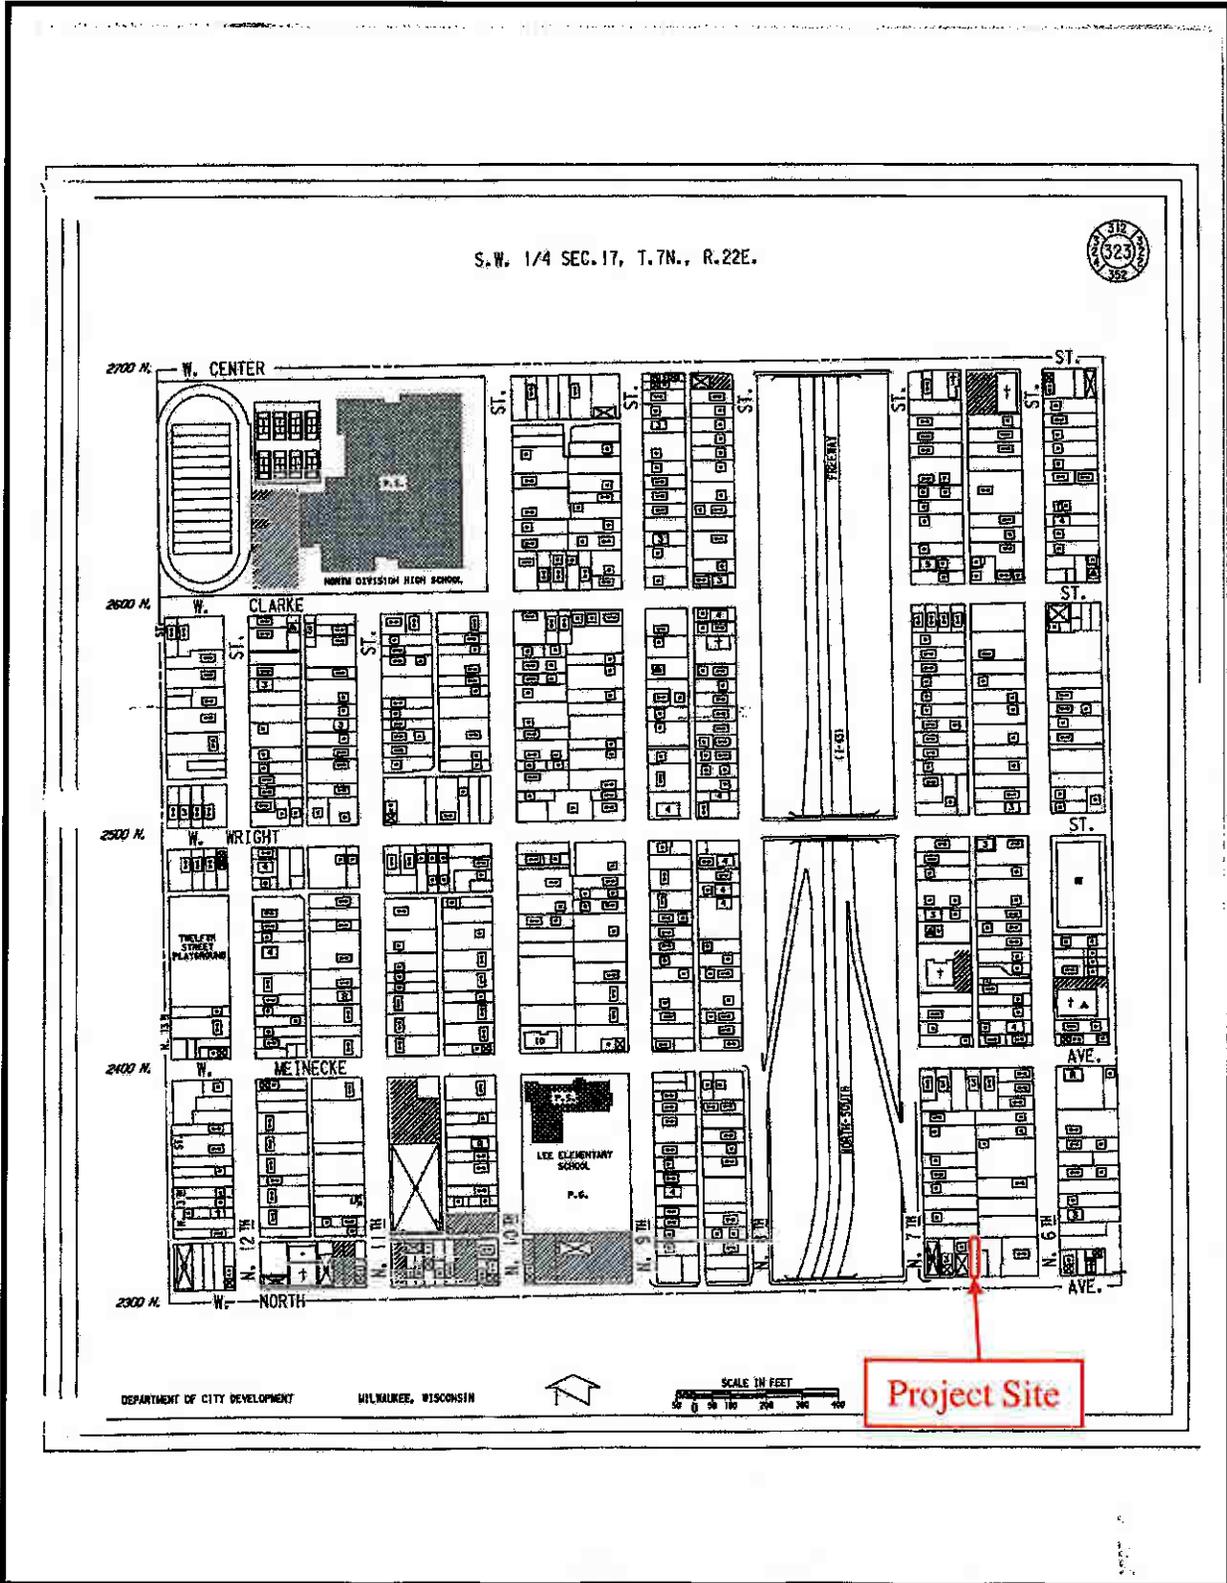
**FIGURE 2**  
**PLAT MAP**  
626 W. North Ave., Milwaukee, WI

SW 17-7-22  
ATLAS P. 323

The project site is located on a block bound by W. Meinecke Avenue to the north, W. North Avenue to the south, N. 6<sup>th</sup> Street to the east, and N. 7<sup>th</sup> Street to the west. The project site is occupied by vacant, grassy land. The general area including the project site is shown on Figure 1, and project site dimensions are presented on Figure 2. An aerial photograph of the site is shown on Figure 3.

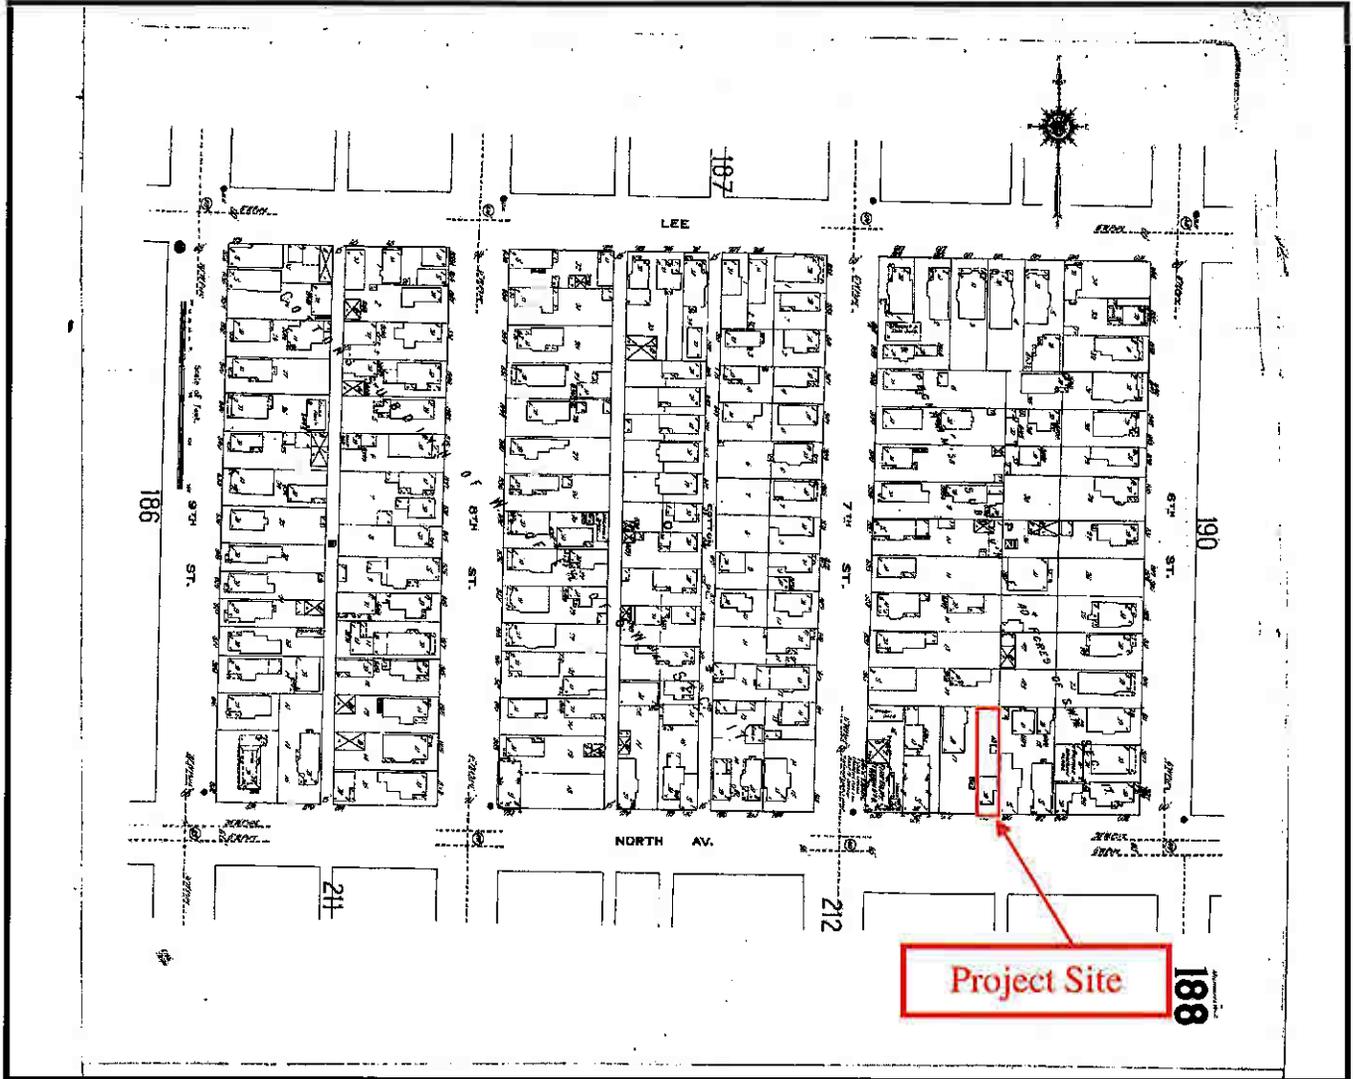
**FIGURE 4**  
1910 Sanborn Fire Insurance Map  
(with updates through 1937)  
626 W. North Ave., Milwaukee, WI

3. Sanborn Fire Insurance Maps indicate the following information regarding the project site:
  - a. A 1910 (*with updates through 1937*) Sanborn Fire Insurance Map shows the project site occupied by a two-story dwelling fronting W. North Avenue, and a detached, smaller building located at the rear. Land uses north, south (not shown) and east include single family dwellings and limited commercial uses. Land uses to the west include a building labeled “Fire Dept. Station No. 8”, a building labeled “Wagon Shed” as well as single family dwellings and stores (Figure 4).

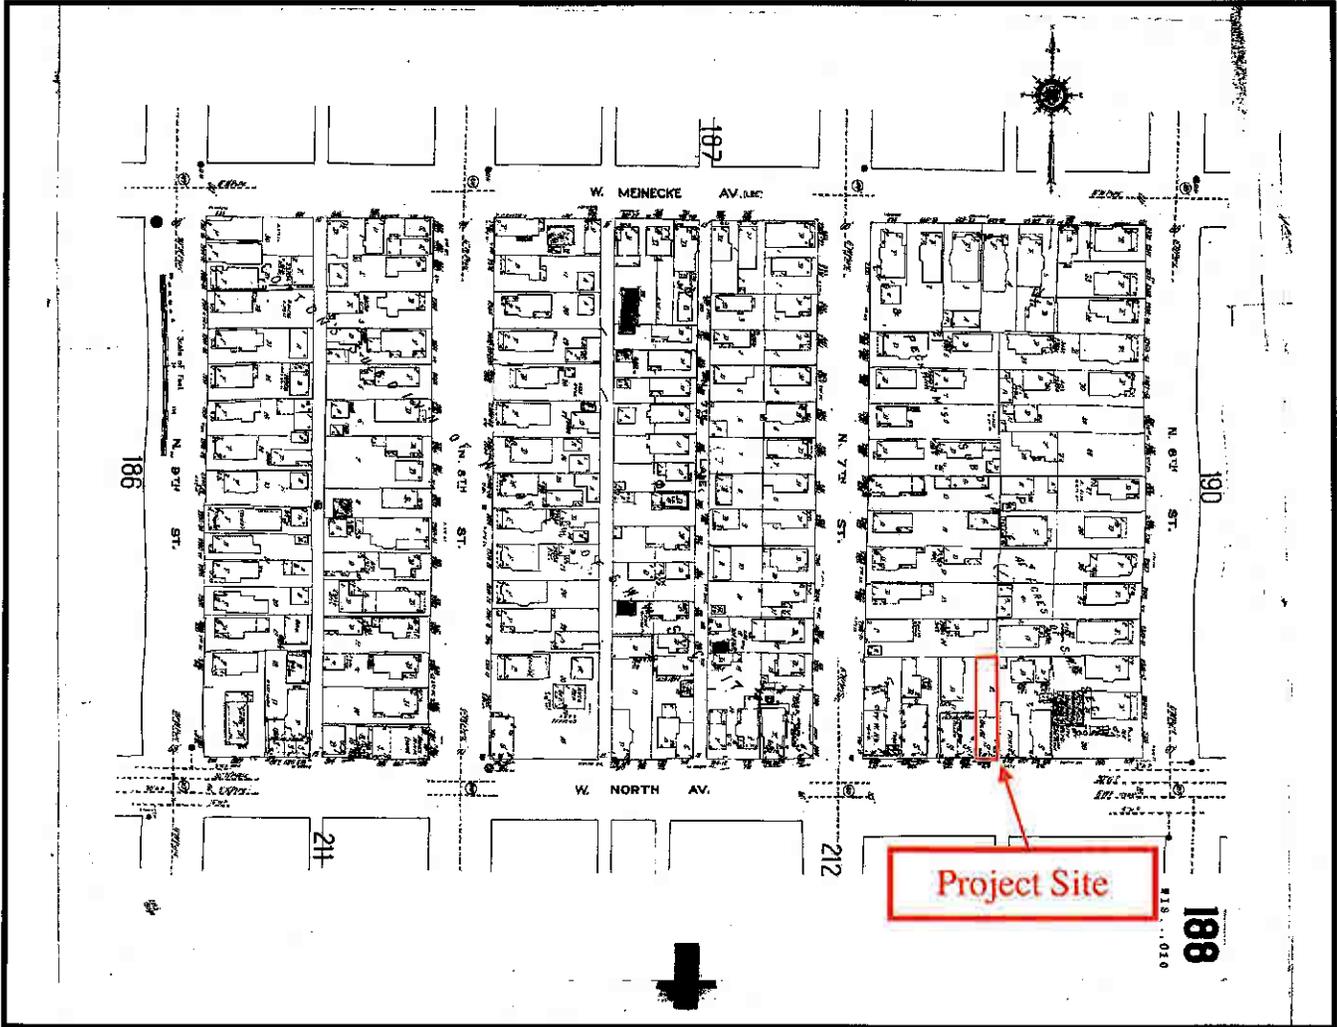
**FIGURE 5**  
**1910 Sanborn Fire Insurance Map**  
*(with updates through 1951)*  
**626 W. North Ave., Milwaukee, WI**

- b. A 1910 (*with updates through 1951*) Sanborn Fire Insurance Map shows the project site occupied by a two-story store fronting W. North Avenue. Land uses north include residential dwellings. Land uses south include residential and commercial uses (not shown). Land uses east are primarily commercial establishments, including a building labeled “Printing”, as well as a parcel labeled “Filling Station” occupied by 3 gasoline tanks and a building labeled “Garage, Auto Repairing”. Land uses west are residential and commercial uses, including buildings labeled “Pyro Bar”, “Filled”, “City Warehouse”, and “Upholstering” (Figure 5).

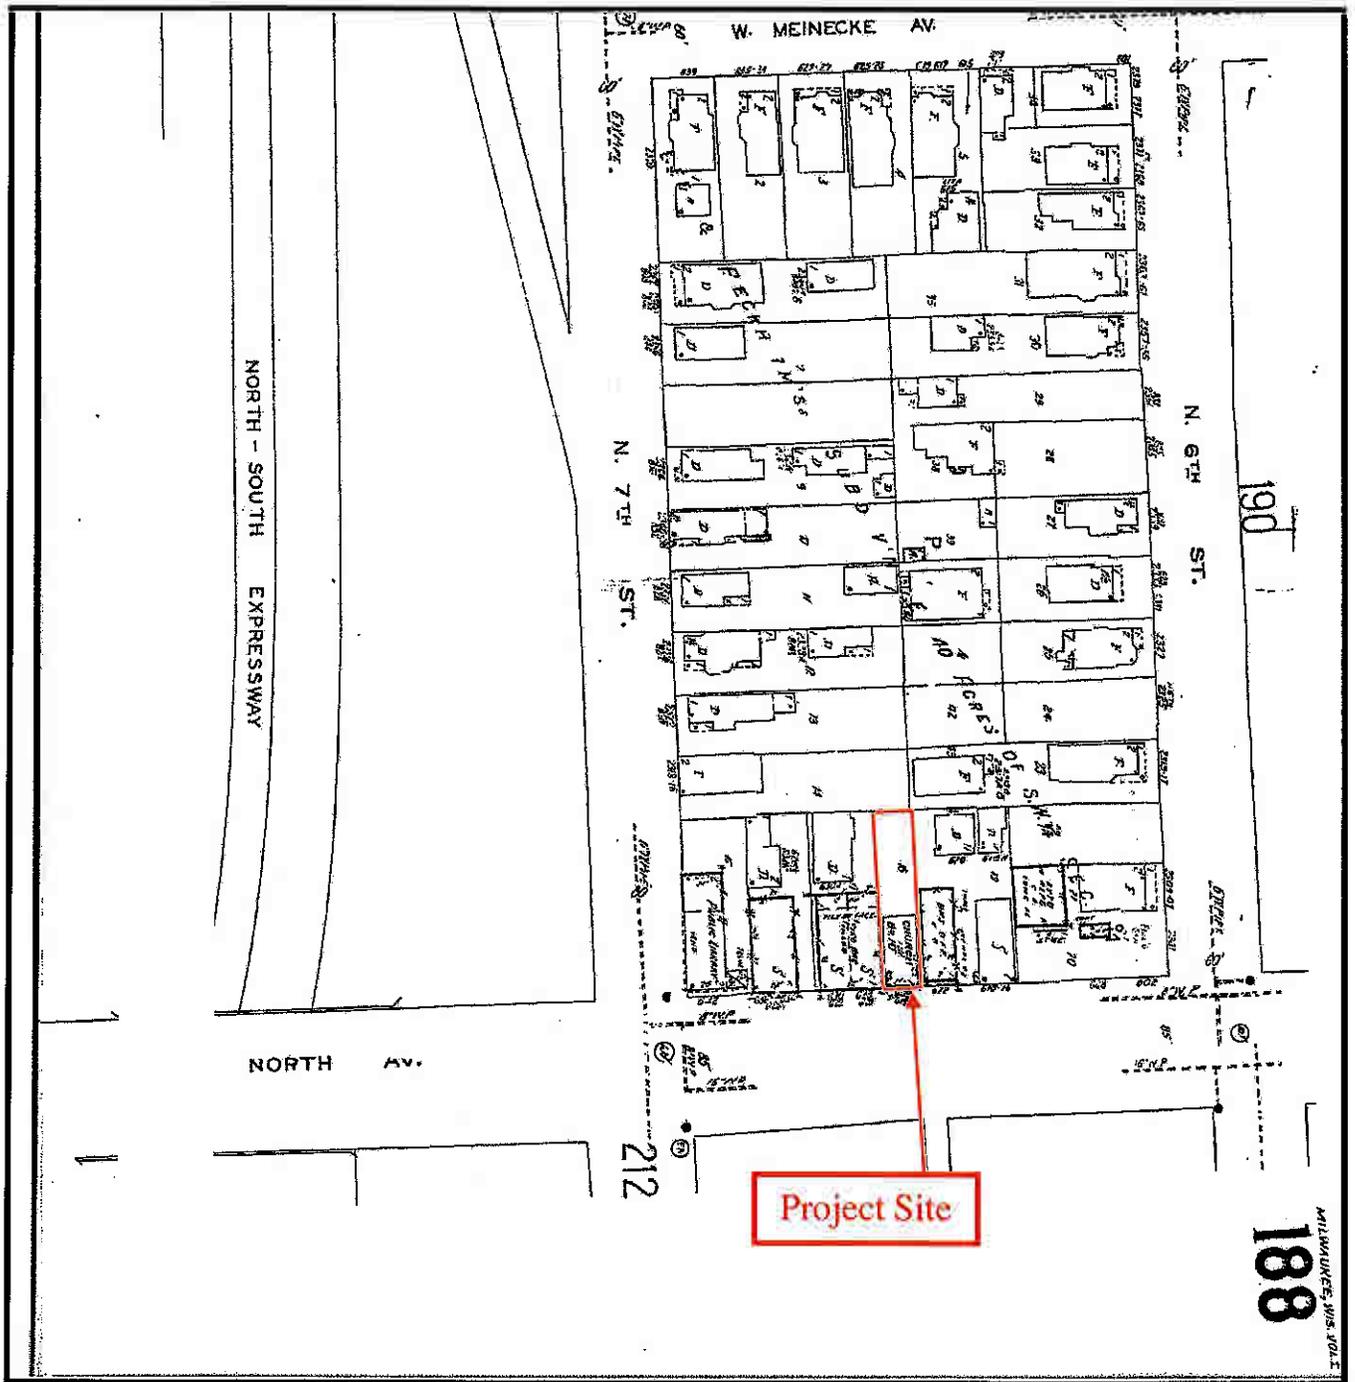
**FIGURE 6**  
1969 Sanborn Fire Insurance Map  
626 W. North Ave., Milwaukee, WI

- c. A 1969 Sanborn Fire Insurance Map shows the project site occupied by a building labeled “Church”. The map shows the same general features as the 1910 (*with updates through 1951*). The filling station located east of the project site is depicted with one gasoline tank. A building labeled “Public Library” and Interstate 43 are shown to the west. A filling station is shown south of the project site, across W. North Avenue (Figure 6).
